# Snowmobile Trail Bump Formation Analysis, Prediction, and Modeling

Final Report  
for  
National Park Service - Yellowstone National Park  
Planning Office  
P.O. Box 168  
Yellowstone Park, WY 82190

August 2000

Michigan Technological University  
Houghton, MI

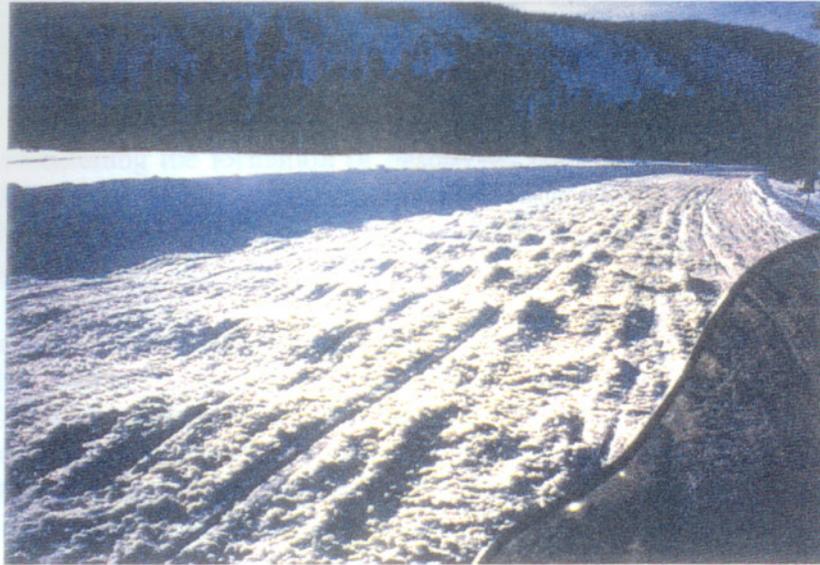
**Figure 2. Bumps on Groomed Snow Road.**

Winter visitation within Yellowstone National Park, as well as several other parks that experience significant snowfalls within the winter months, has grown considerably over the past decade. Snowmobile traffic into the park at the West Yellowstone entrance commonly exceeds 1000 sleds per day. Since most of these snowmobiles are headed to Old Faithful and back out by early afternoon, the majority of the vehicles pass into the park within only a few hours in the morning and come back out over a short period in mid-afternoon. This heavy traffic causes the groomed snow road to bump up quite rapidly resulting in an extremely rough ride. Roughness results in an "unpleasant" experience as well as drastically slowing traffic flow, especially on the trip back out in the afternoon. Figure 1 is a photo of some of the large numbers of snowmobiles at Old Faithful. Figure 2 shows some of the resultant bumps.

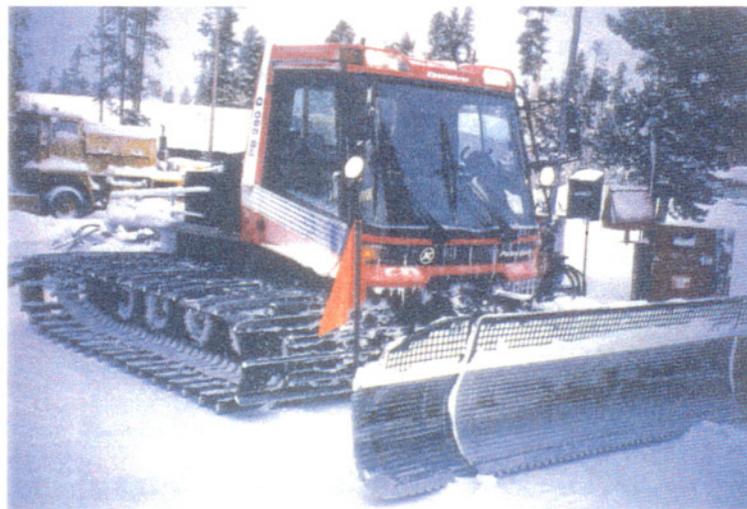
**Figure 3. Grooming Equipment.**

Currently, grooming of the snow road is performed mostly at night. This is the safest time to groom to avoid collisions between snowmobiles and the groomer. In some cases, this is also the best time for grooming, especially if snow set up time is deemed the most important grooming parameter. If grooming is performed in early evening, as is usually the case, the groomed snow road can set up over night with very little traffic affecting the set up. Figure 3 is a photo of one of the groomers used in the park.

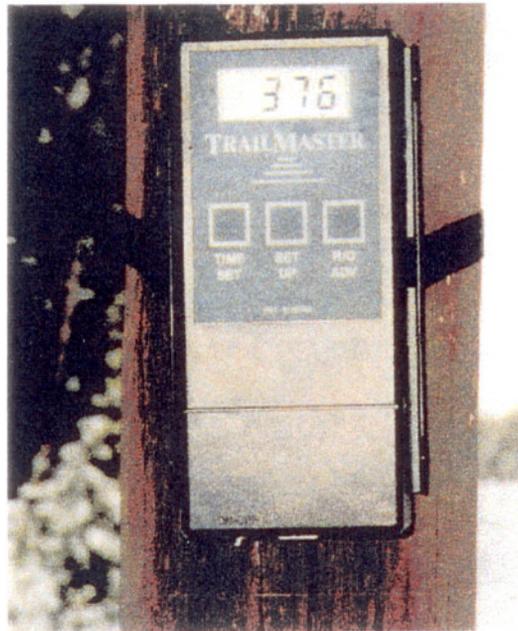
Figure 7. Electronic Trail Counter.

Electronic trail counters were also programmed for use on-site at Yellowstone. KRC has 2 of these units that can be set up to count single lanes of traffic so as to decipher the direction of travel of snowmobiles moving on the trail. These counters record a vehicle passage number and time for every passage. From this data, the exact count at the time of each profile measurement can be determined. Figure 7 is a photo of one of these counters.

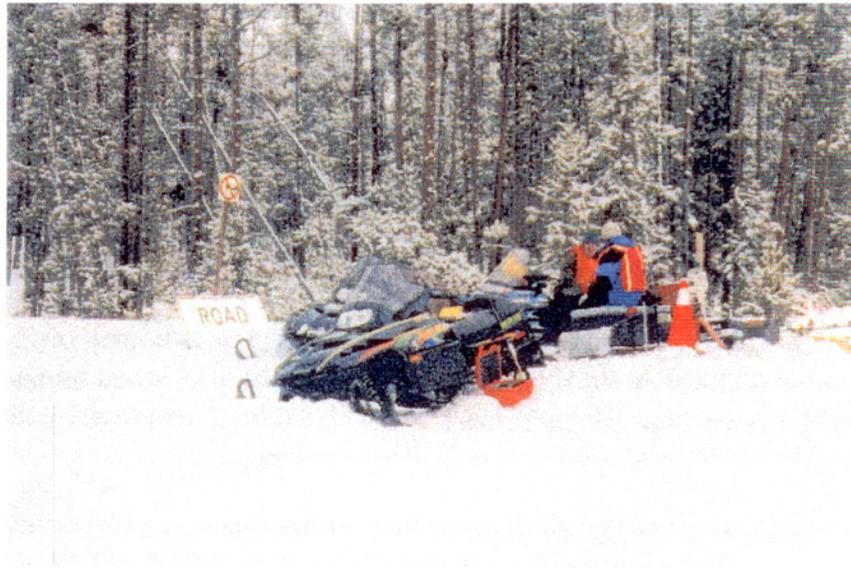
Figure 11. Test Site Setup.

A test section called "West Gate Section" or "Standard Test Section" was set up about 1/4 mile into the park from the West Entrance. This section was 250 feet long and was located just to the east of the service road located on the north side of the road. Baseline reference stakes were placed approximately 50 ft to the north of the centerline of the snow road and 250 feet apart at both ends of this section in the ditch alongside the road. These stakes were left in place throughout the test period to allow for comparison of profiles from day to day. Prior to each days measurements at this site, a row of cones was set down the center of the snow road to attempt to keep traffic in their own respective lane. Traffic was re-routed into the lane that was not being measured during each profiling. Figure 11 is a photo of the instrumentation setup at this site and Figure 12 shows the lane designation using cones.

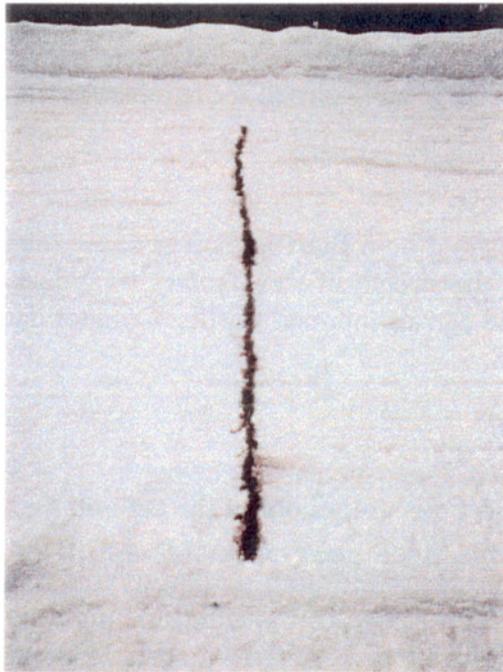
**Figure 13. Particle Movement - Peak - No Traffic**

To visually depict snow movement, a line of ash was placed perpendicular to the snow road transecting the traffic lane at several locations. The test was performed between 9:00 and 10:30 after the heavy morning traffic had passed on the trail inbound. At this time, the bumps were about 3 inches high. Speeds were normal or about 45 mph. The lines of dark colored ash were about 1" wide and 1/4" thick. As snowmobiles drove over these lines it was hoped that the movement of ash would depict the movement of snow particles also. The following figures are photos of this test. All of the photos shown here have the direction of travel from right to left across the page. Figure 13 is a photo of an undisturbed line of ash that is placed on top of and along the peak of a single bump. Figures 14 through 16 are 3 progressions of the same ash

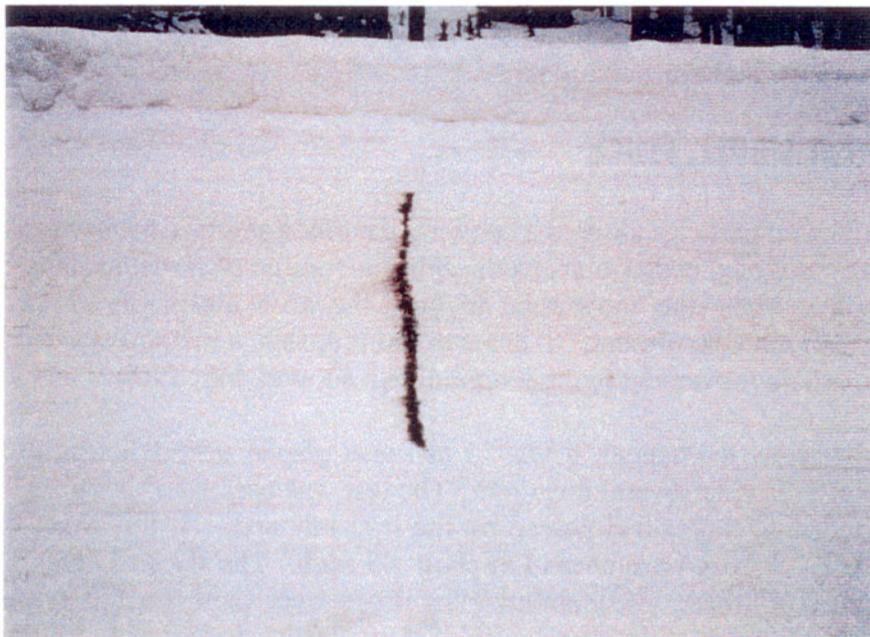
**Figure 14. Particle Movement - Peak - +3 Snowmobiles.**

sample after 3, 23, and 43 snowmobile passes respectively. 3 snow coaches also passed over the sections between the last two photos. From these photos it is clear that the majority of particles are moving in the direction of travel, the particles are being “pulled” along by the snowmobile.

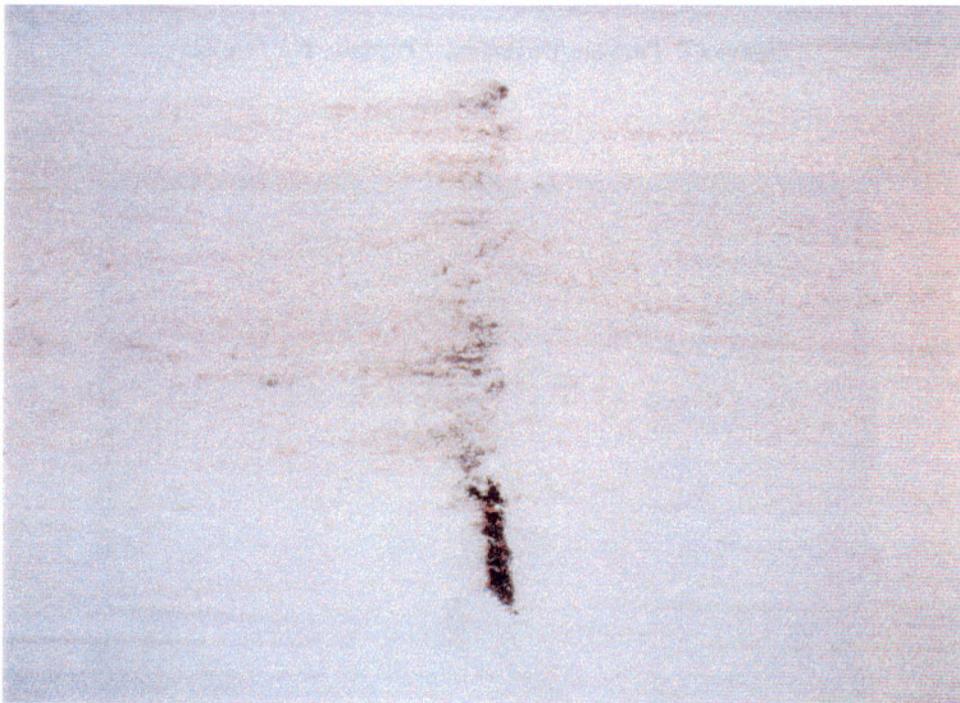
**Figure 16. Particle Movement - Peak - +20 Snowmobiles + 3 Snow Coaches.**

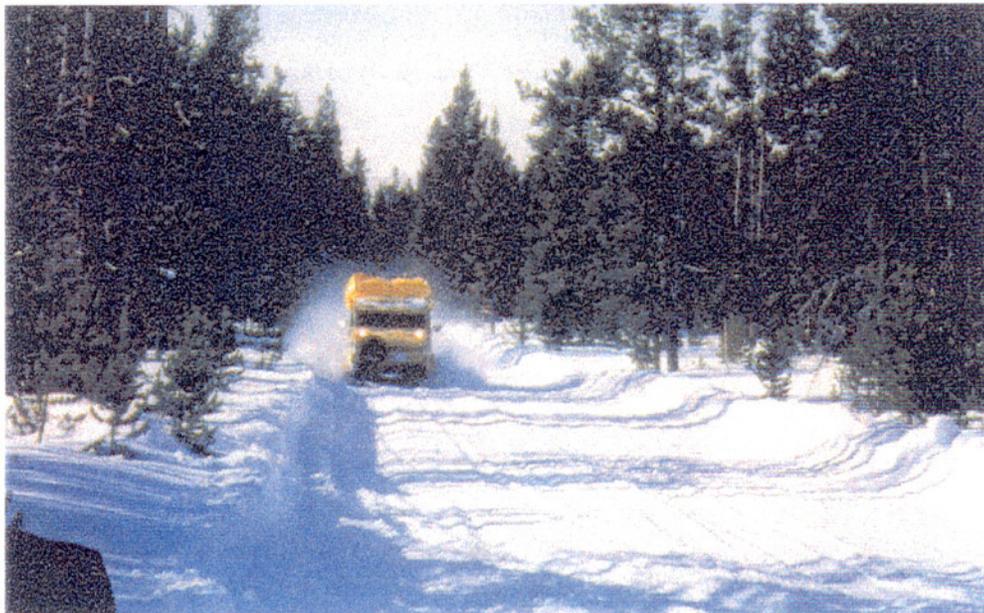
**Figure 21. Snow Coach on Test Snow Road.**

In an attempt to determine the scenario of bump formation and snow road degradation caused only by snow coaches, a special snow road section was set up off of the main snow road on a side road near the West Yellowstone entrance. This piece of road was groomed 3 days prior to the proposed test and allowed to set up and sinter. On the day of testing, 2/17/2000, a Bombardier snow coach was brought to the test site and driven over the specially made snow road. Figure 21 is a photo of this vehicle on the snow road.

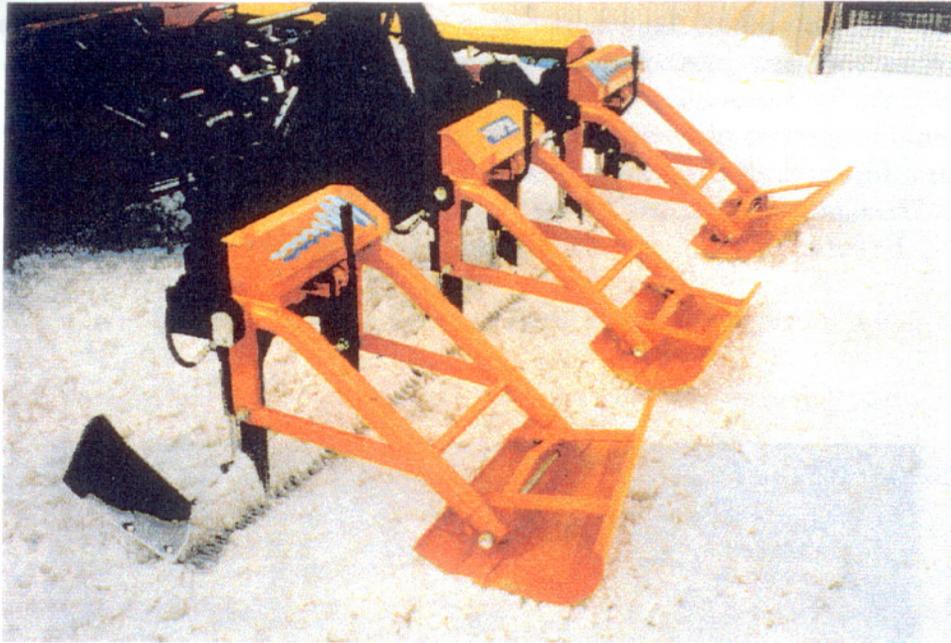
Figure 25. Renovator Grooming System

A comparison was made between normal grooming and use of the Yellowstone Track Systems, YTS "Renovator" on the snow road section near the entrance at West Yellowstone. This test was to determine if the "Renovator" could cut through the frozen bumps and leave a smoother snow road. The Renovator is a front mounted grooming system designed to cut deeply into hard-packed snow road surfaces to remove any old bumps and then re-smooth the surface.

Figure 25 is a photo of the Renovator system.

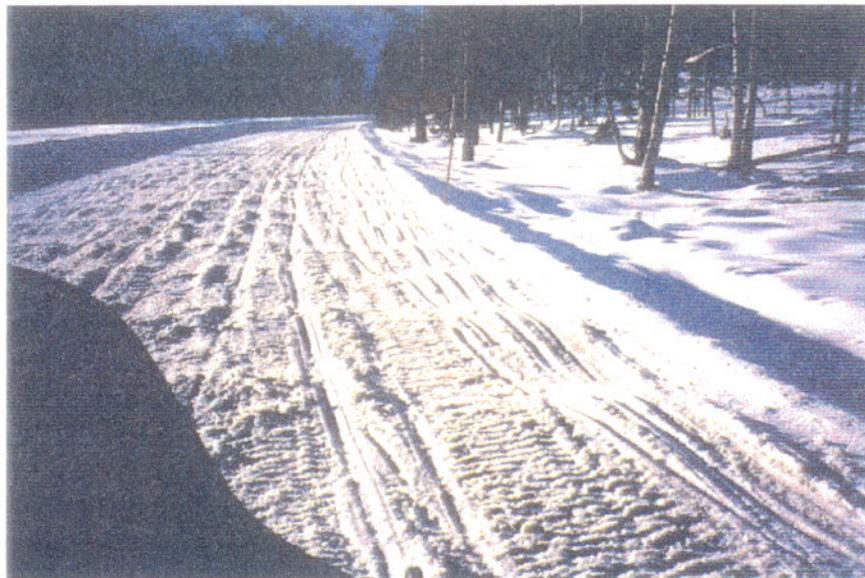
**Figure 26. Bumps on Corner.**

Figure 26 is a photo of bumps on the inside of a corner.
